Arab Journal of Nuclear Sciences and Applications

Inspection of Some Components of the Nuclear Reactor TRICO II

In order to restart the Research Reactor Trico II, nuclear components are inspected using two main Non-Destructive Testing (NDT) methods, namely Visual Inspection (VI) and Ultrasonic Testing (UT). Visual method was needed to inspect the TANK using underwater camera ARECONT VISION and the USB2.0 endoscope. Ultrasonic method was needed to inspect octagonal concrete structure using a flaw detector Proceq Pundit PL-200PE for uniformity and quality controls. The inspection showed that the reactor tank has not been degraded. Indeed, out of about one hundred photos taken with both underwater cameras, only two shows small degradations on the tank wall. One concerns the horizontal ring 1, which is not well stucked on the tank wall. The second concerns the vertical weld (CV1), which shows a visible spot on the weld due probably to dust accumulation. The biological protection layer of the octagonal concrete structure is not also degraded. The calculated concrete structure elasticity modulus is given by $G = 192\,558,53 \pm 43811,93$ Mpa.

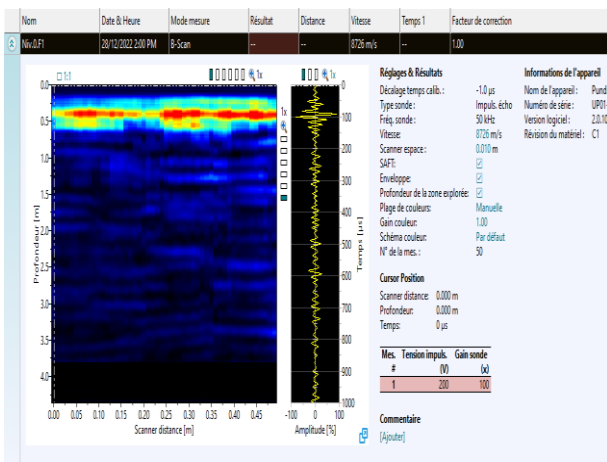
Fig. (4) a) and b) respectively, show an example of the ultrasonic result on the face 1 (Niv.0.F1) and the process of the B-Scan on a test piece.

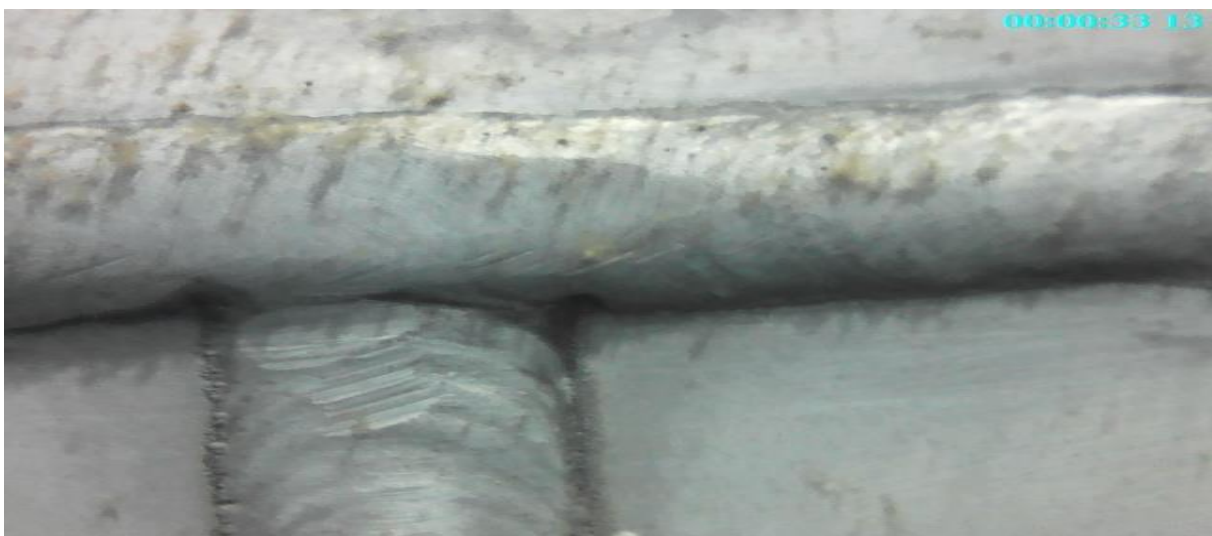
Fig. (5): Photo of good welds in T: horizontal weld (CH2) and vertical weld (CV2). The photo was taken with the underwater endoscope USB 2.0.

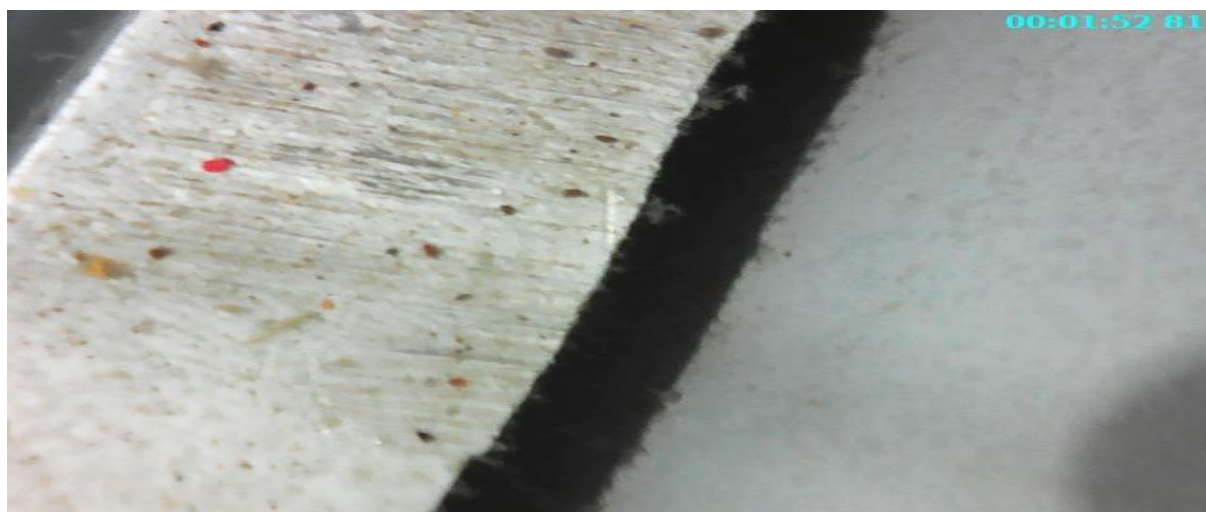
- The photo of figure 6 was taken with the underwater USB.2.0 endoscope.
- Observation: Its dimensions are not uniform. This indicates that the horizontal ring 1 is not well stucked on the tank wall.
- Remedial action: The horizontal ring 1 must be well stucked on the tank wall.
- The photo of figure 7 was taken with the underwater USB.2.0 endoscope.
- Observation: The photo shows a visible spot on the weld, due probably to dust accumulation.

Fig. (6): The photo shows the Horizontal ring 1.

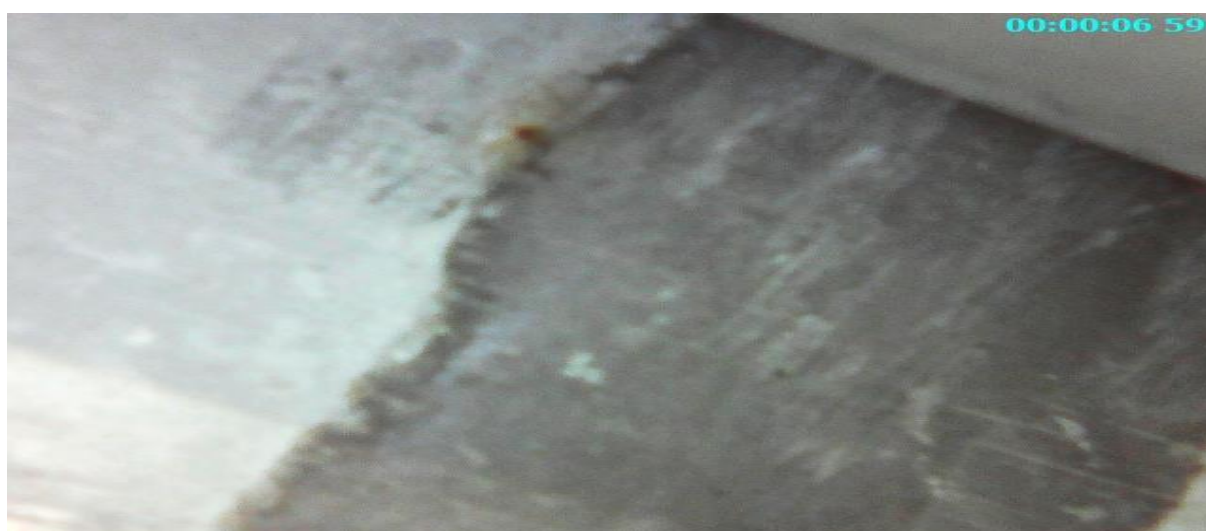
Fig. (7): The photo shows the Vertical weld (CV1)

- Remedial action: A test of pressurized water can be done to verify the dust accumulation hypothesis.
- Photos of figure 8 was taken with the underwater camera ARECONT VISION.
- Observation 1: The first image indicates the presence of a fallen object in the tank bottom.
- Remedial action: An appropriate tool is conceived to remove it from the bottom.
- Observation 2: The second image indicates the presence of wires in the tank bottom.

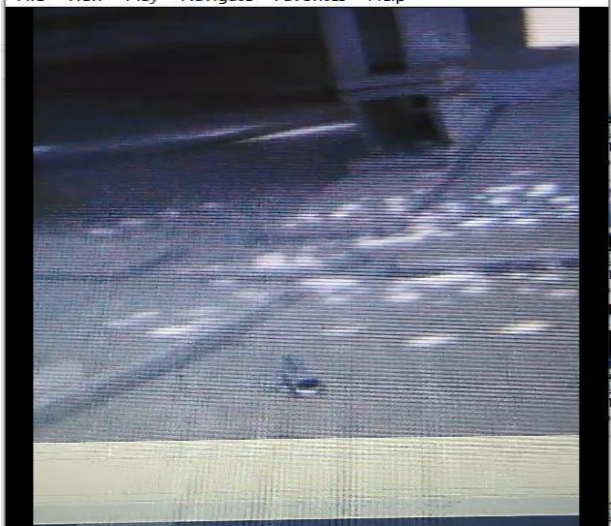
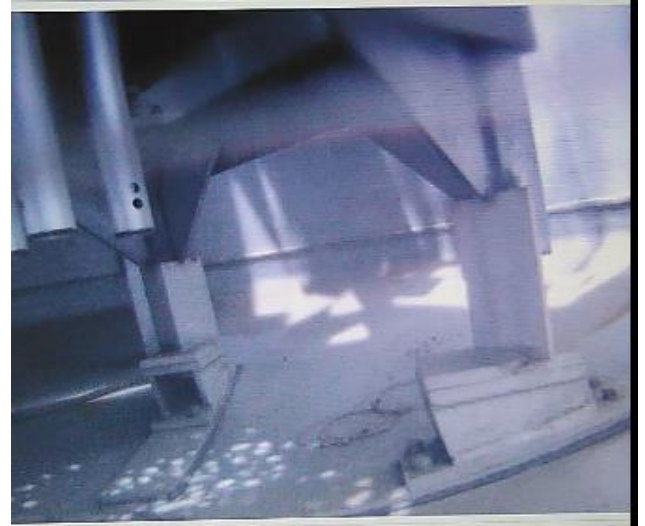
Fig. (8): The two photos show locations of the two fallen objects in the tank bottom.

- Remedial action: The above-mentioned tool will be used to remove them from the tank bottom.
