Arab Journal of Nuclear Sciences and Applications

Non-Destructive Testings of the Lifting Hook and Heat Exchanger Circuits of the Research Reactor TRICO II by Liquid Penetrant and Ultrasonics Testing Methods

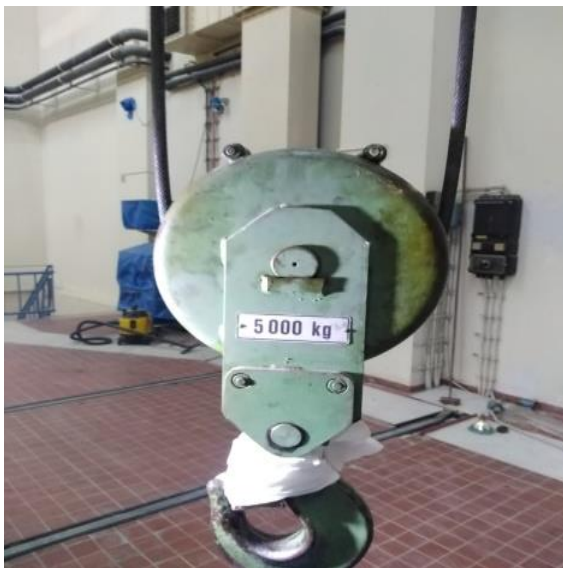
These products (fig.1b) were used to examine the lifting hook of the hoist STAHL 5000kg made of ordinary steel (fig.1a).

Fig. (1): Photo a) shows the hoist STAHL 5000kg hook and photo b) liquid penetrant testing products used for PT

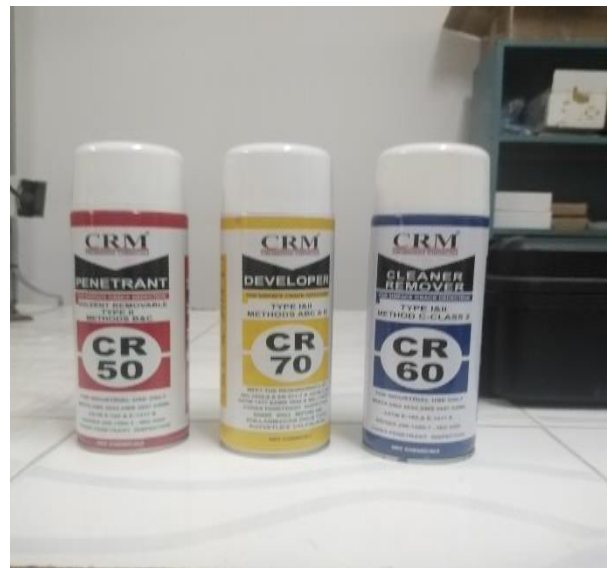
b)

To inspect the surface, the hook was first cleaned and dried, and then the colored red penetrant was sprayed. After ten minutes, the excess of colored red penetrant was removed. Finally, the developer was sprayed and the observation was done with white light of 750 lux.

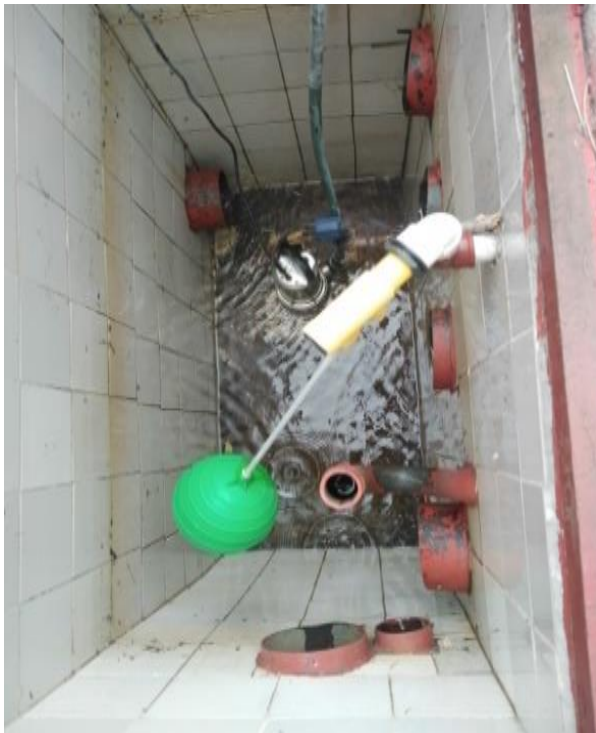
wall piping of the secondary circuit of the heat exchanger (fig.2a).

The inspection concerns only the external part of the heat exchanger of the secondary circuit piping.

Fig. (2): Photo a) shows the end of external secondary circuit piping of TRICO II and photo b) the multifunction video inspection KC-350 used for the indirect visual inspection

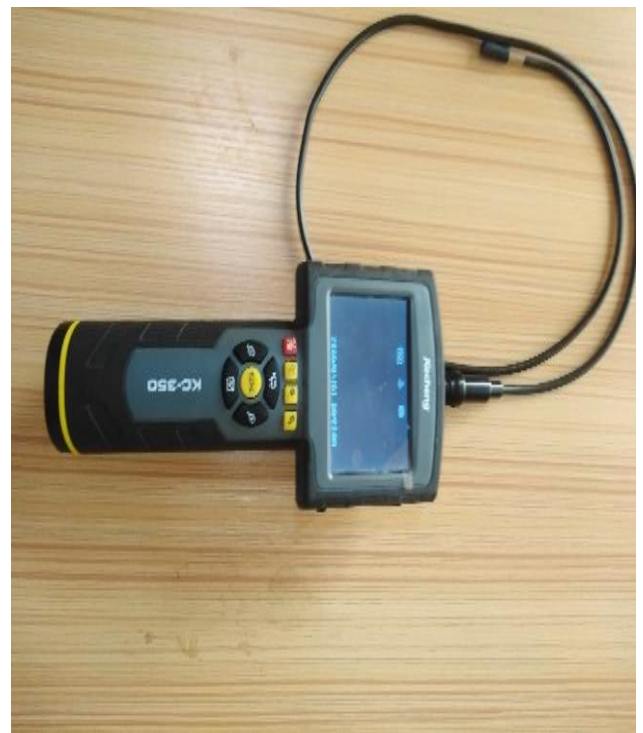
b)

The multifunction Video Inspection KC-350 endoscope (fig.2b) was used to inspect the internal

The multifunction video was introduced through the wall of the pipe and pictures were captured.

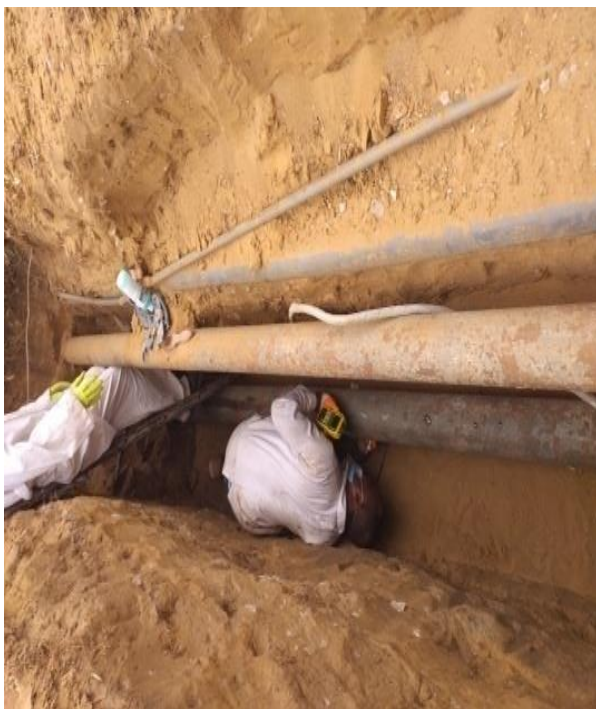
The thickness gauge ATG II (fig.3b) was used to determine thickness of external part of the heat exchanger secondary circuit piping (fig.3a).

Fig. (3): Photo a) External pipe of secondary circuit of TRICO II reactor and photo b) the gauge thickness ATG II used for the measurement of thickness

There is thickness variation of controlled surface due to presence rust and corrosion. The nominal thickness of the pipes being 5mm, three groups of values are presented in our table:

Values lower than 5mm show the presence of corrosion.

Remedial action: the replacement of pipe is required.

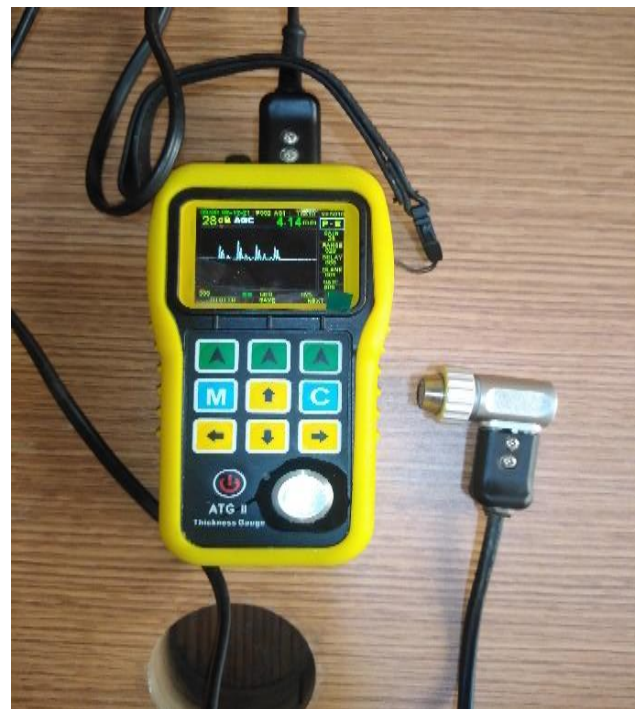
b)

First, the calibration of the thickness gauge ATG II was done by applying couplant on the surface of 4.00 mm steel block calibration. Next, putting the probe on the part via the couplant, completely permitted to couple it with the part, then pressing arrow key until the screen echo waveform was moved and displayed on 4.00, the gain is automatically adjusted by software as well. After the waveform moved and displayed 4.00, the calibration was done and the unit was ready for inspection.

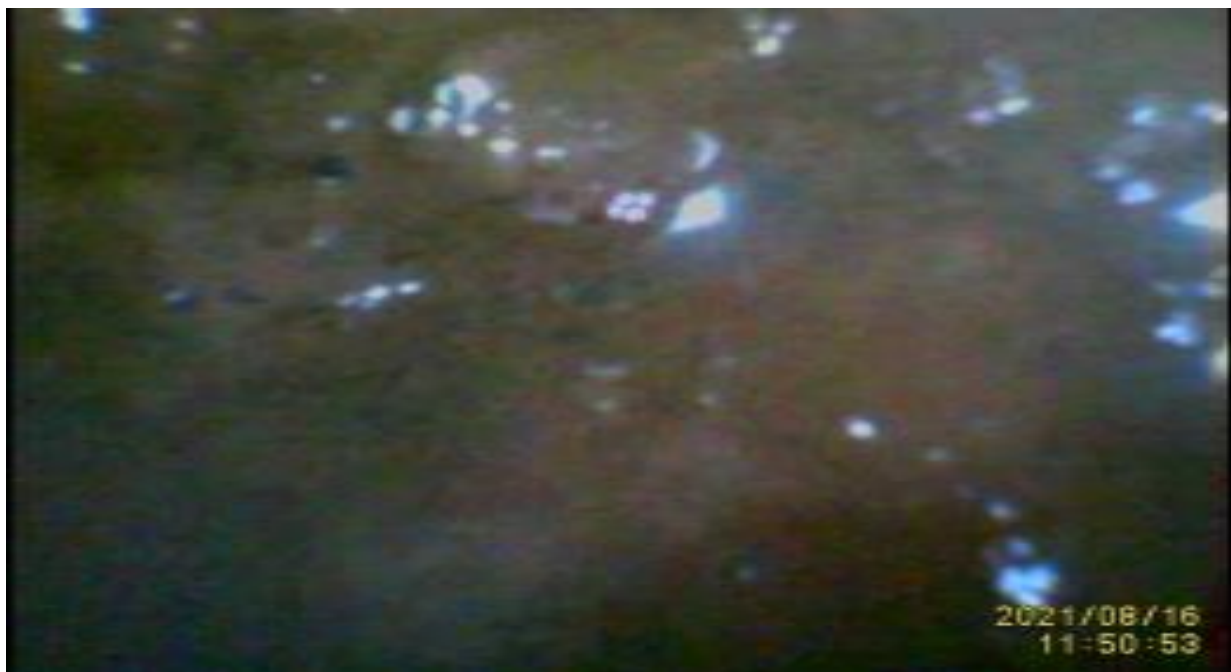
The fig.5 shows the photo of internal wall of secondary circuit pipe of TRICO II reactor. There is presence of rust and corrosion.

Fig. (5): View of internal wall of secondary circuit pipe of TRICO II reactor after visual inspection with the multifunction video KC350

Remedial action: pipe must be replaced.
