Arab Journal of Nuclear Sciences and Applications

Inspection of Some Components of the Nuclear Reactor TRICO II

In order to restart the Research Reactor Trico II, nuclear components are inspected using two main Non-Destructive Testing (NDT) methods, namely Visual Inspection (VI) and Ultrasonic Testing (UT). Visual method was needed to inspect the TANK using underwater camera ARECONT VISION and the USB2.0 endoscope. Ultrasonic method was needed to inspect octagonal concrete structure using a flaw detector Proceq Pundit PL-200PE for uniformity and quality controls. The inspection showed that the reactor tank has not been degraded. Indeed, out of about one hundred photos taken with both underwater cameras, only two shows small degradations on the tank wall. One concerns the horizontal ring 1, which is not well stucked on the tank wall. The second concerns the vertical weld (CV1), which shows a visible spot on the weld due probably to dust accumulation. The biological protection layer of the octagonal concrete structure is not also degraded. The calculated concrete structure elasticity modulus is given by $G = 192\,558,53 \pm 43811,93$ Mpa.

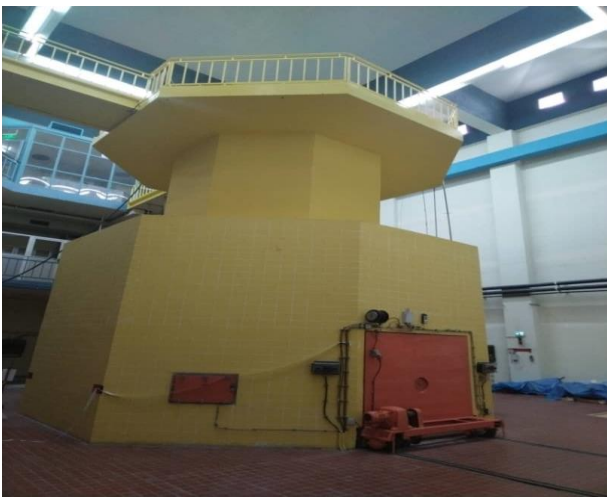
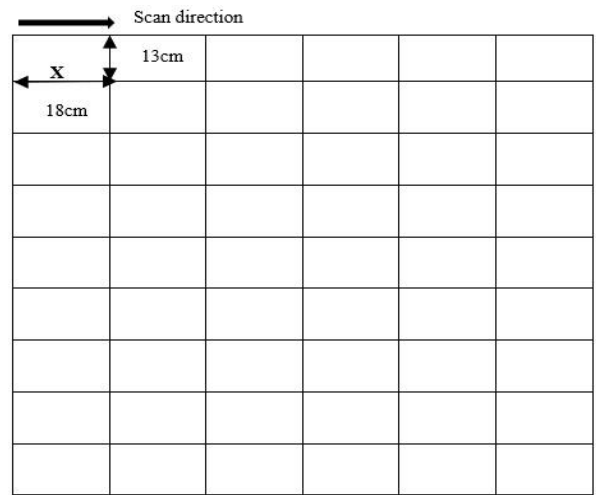
Fig. (3): Photo 3a) and scheme 3b) show the octagonal concrete structure of Trico II and the mesh defined for B-scan, respectively. The scanning begins by the grid X.

Provided the fact that the inspection is the first since 1972, the written procedure required 100 percent of inspection extension. Therefore, a mesh was defined in each face of the concrete structure. Figure 3a shows the photo of the octagonal concrete structure of Trico II. Given the equipment dimensions: $(18 \times 13) \text{ cm}^2 = 234 \text{ cm}^2$, each grid of 234 cm^2 is defined in the mesh to be a point of ultrasonic measurement (fig. 3b). The result of each face is the average of three measurements. The flaw detector Proceq Pundit PL-200PE display gives a left area for B-scan (The transversal section of the structure that represents the different densities of the structure by different colors) and a right area for A-scan (The pulse-echo method that represents the amplitude of the echo in the structure). For a measurement, the detector is placed perpendicularly to the face. Note that the A-scan permits to determine the longitudinal velocity v_l in the concrete of a known width. B-scan is obtained by changing the grid in the scan direction. The example given in figure 4a represents a UT measurement on face 1 (Niv.0.F1), whereas the figure 4b explains the UT measurement process on a test piece.

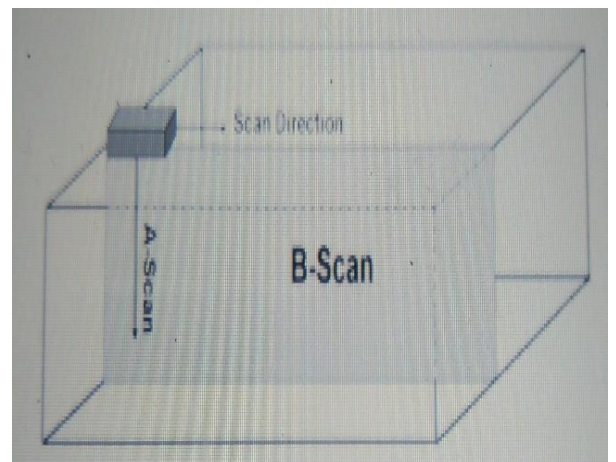
Fig. (4) a) and b) respectively, show an example of the ultrasonic result on the face 1 (Niv.0.F1) and the process of the B-Scan on a test piece.

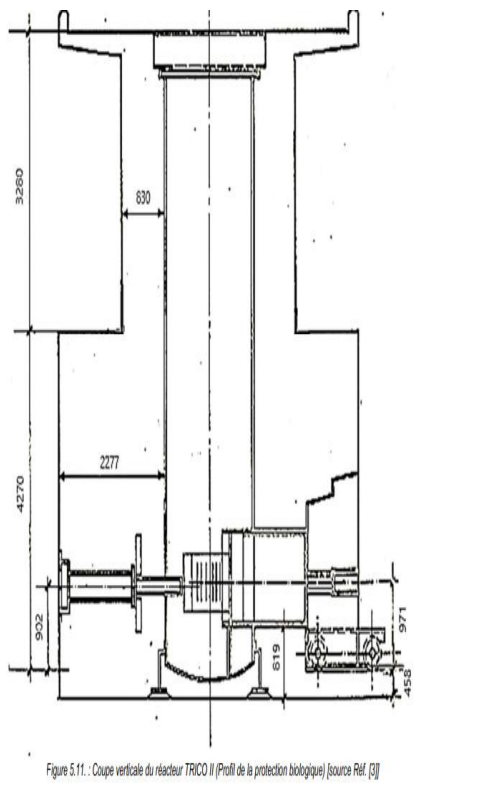
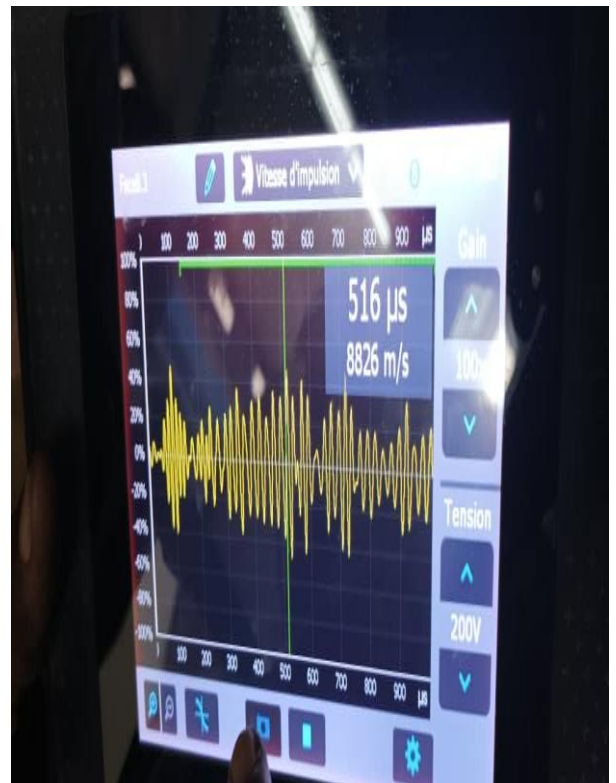
Fig. (9): Figures a) and b), respectively, show the vertical section of the Trico II and the measurement in pulse-echo mode on one grid.
