Paper presented in the 10th African Conference on Research Reactor Safety, Operation & Utilization, Cairo (Egypt) 27 to 29 Nov. 2022, organized by the International Atomic Energy Agency in cooperation with the Egyptian Atomic Energy Authority

Ageing Management Activities at the Ghana Research Reactor-1 Facility

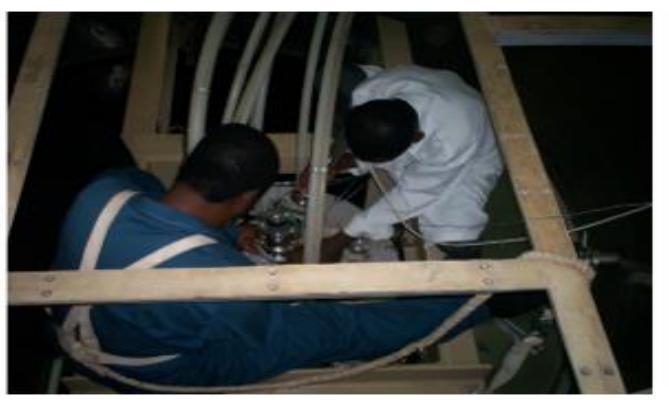
Fig. 2.4a: Staff engaged in the control rod drive mechanism replacement

Programmes for periodic assessment based on broad operational data collection, preventive maintenance, and continuous monitoring of the control rod drive mechanism revealed that it was deviating from the normal operating condition. The procedure for its removal and replacement was prepared and approval was given by the regulatory authority. The original control rod drive mechanism was removed and a new one supplied from CIAE was replaced successfully. Figures 2.4a, and 2.4b shows respectively staff engaged in the removal of the old control rod drive mechanism and installation of the new one. Reference [5]provides detail of the procedures involved.

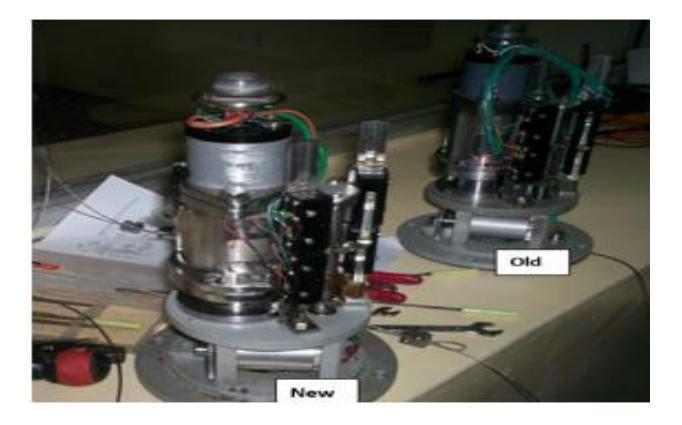
Fig. 2.4b: Old and New Control Rod Drive Mechanism

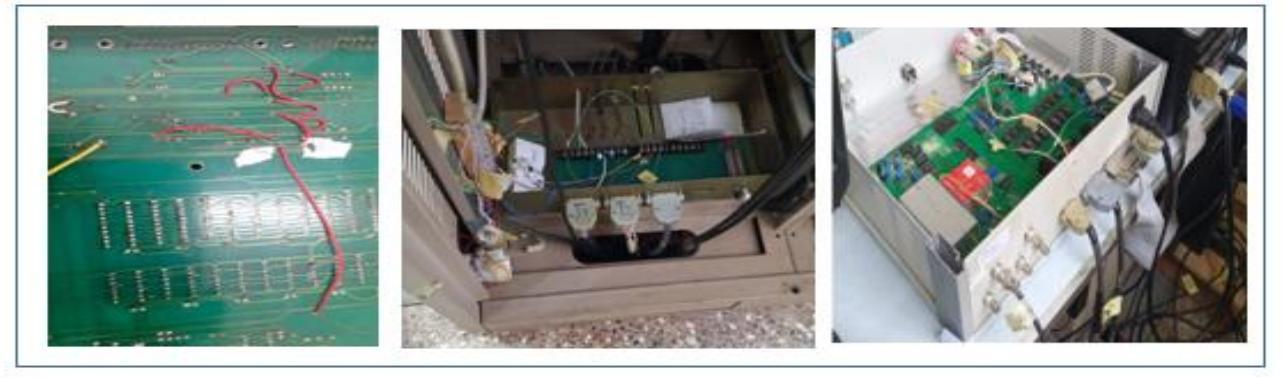
Fig. 3.0 Dry Joint, Wear & Tear conditions of Control and Instrumentation Circuit Board

In the preparation for the first criticality test for GHARR-1LEU core, refurbishment work was done where a lot of active electronic components were replaced. The MCCLS was the main control system used. The first criticality test was performed successfully (August 10, 2017). Ever since the instrumentations and control systems remained effective and have supported operation. However, there were a series of problems encountered with the instrumentations and control systems. The first problem encountered was the software corruption of MCCLS system which halted reactor operation and utilization. The updated software and a detailed approach to the installation to restore the system its normal functionality were received from CAIE. The procedures were followed by the staff and the system was restored. Subsequent problems encountered were due to dry solder joints of active and passive components of the circuits. Other issues encountered with the electronic board were the connecting plugs which were not gripping firmly due to wear and tear that came as a result of periodic opening and servicing. These problems were solved by re-soldering components terminals and tracing the circuit lines and linking those suspected of not working well with a suitable cable. Figure 3.0 shows these conditions. Frantic efforts are still underway in calibrating to install new control circuit boards supplied by CIAE to replace the old ones for the two control console systems.

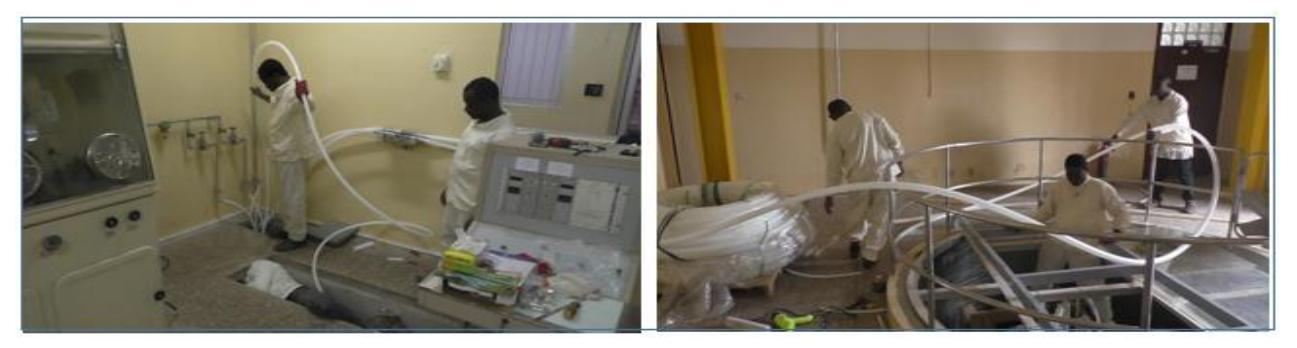
Fig. 3.1 Installation of new irradiation tubes connecting the PTS to the reactor Core.

Tubes installed in the Pneumatic Transfer System (PTS) for sample transfer into and out of the reactor irradiation site became weak and brittle. The old tubes which existed in operation for over 23 years were removed and new ones installed. The new tubes installed in place have the same dimensions ranging from tubes of internal diameter (mm) of 19.0, 32.0 and 16.0 and thickness of 10.0, 8.0 and 4.0 mm respectively. This was done to avoid tubes busting or breaking during reactor operation. Figure 3.1 shows pictures of staff engaged in the replacement work. Safety procedures and work orders were approved before the commencement of the work. Apart from the PTS tube replacement, the Triode for Alternating Current (TRIAC) control unit for the sample transfer system was redesigned. This came as a result of not getting the exact original component (TRAC KS3-8 87.7) in the Ghanaian local market for replacement when it malfunctioned. This issue of the non-availability of the component to buy locally made it difficult to operate the PTS. So the existing circuit was studied and a new control unit has been designed, constructed and installed using an equivalent component (BTA-16) to help do away with the obsolescence of the original TRIAC. Fig. 3.2a and 3.2b show respectively original components, TRAC KS3-8 87.7 on the circuit board and the new board with BTA 16 TRIAC.

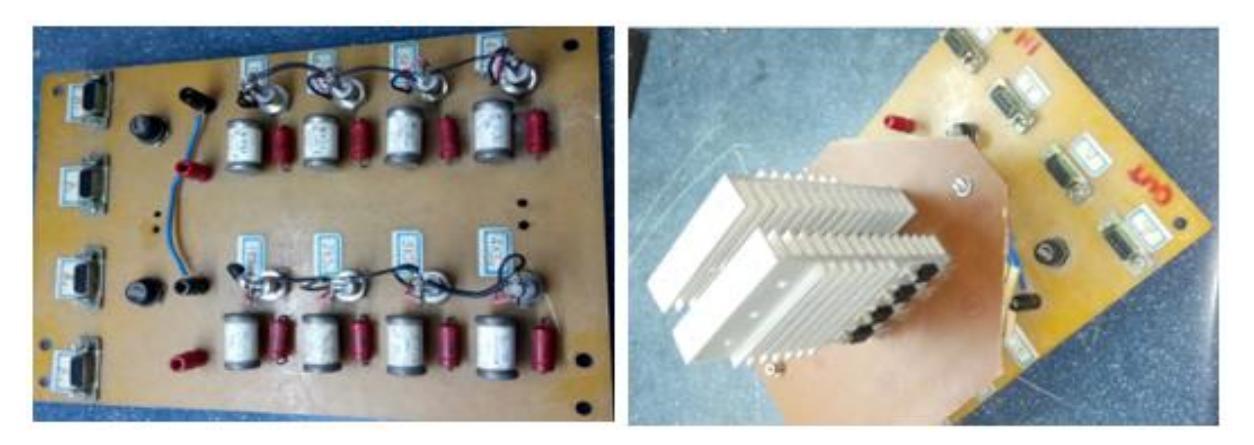
Fig 3.2a The Original TRIAC control unit

Fig. 3.2b the new board with BTA 16 TRIAC

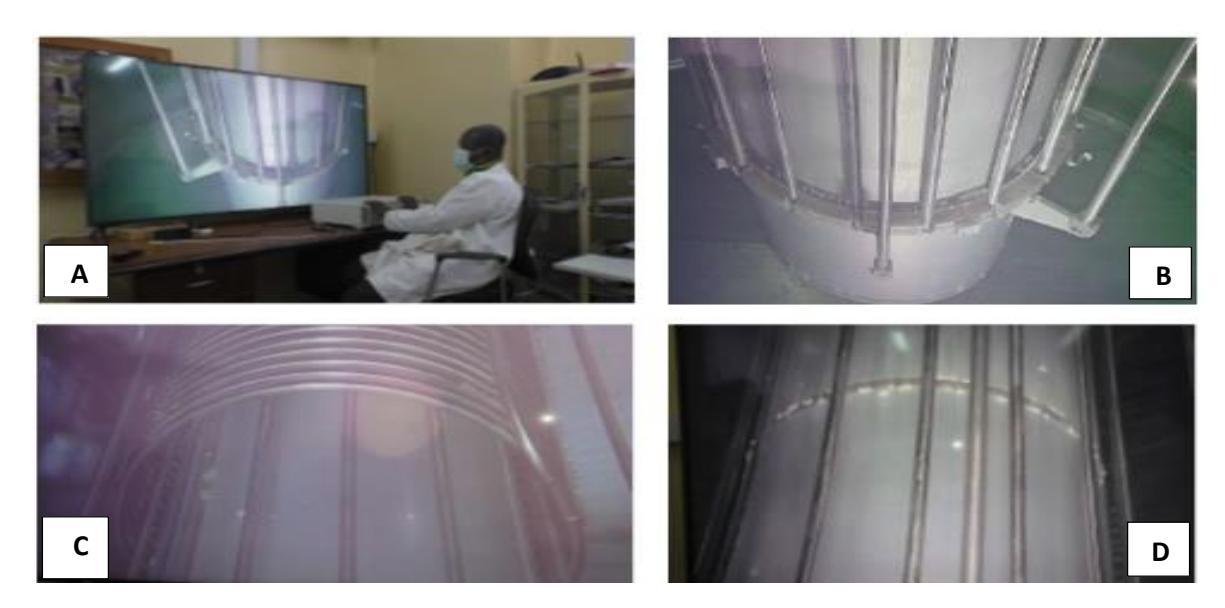
Fig. 3.2 Inspection of SSCs of the GHARR-1 reactor vessel, pool lining and associated structure

In order to detect any commencement of deterioration or deformation on the reactor vessel structure, pool liner and associated structures inside the reactor pool, a physical inspection of the above-mentioned elements has been given a new approach in assessing their physical status in the ageing management activities. In this new approach, underwater cameras connected to large-screen LED TV is now being used to view the structures for any hidden developing deformation. Previous work of such inspection after the GHARR-1 core convention is shown in Figure 3.2. The inspection process displayed various sectional views of the reactor structure and the associated components. In Fig. 3.2A is Staff in front of the camera control unit and the television monitor set-up projecting the views of the structures of reactor vessel,

pool lining and the related components. Fig. 3,2B is the Reactor vessel and it supporting structures (tie rods) and bottom of reactor pool bottom liner, Fig 3.2C is the reactor vessel and cooling coil arrangement and Fig. 3.2D is the mid-way section of the reactor vessel, showing conspicuously a whitish substance at one of the horizontal welding joints. The monitoring of the outer reactor vessel, pool liner and the associated supporting structures generally show and give a clear state of the structural integrity. As shown in Fig 3.2, the reactor outer vessel, the supporting structures and liner are maintained. However, the formation of the whitish substance will have to be understudied.
